Failure Analysis of OH-58 Kiowa Warrior Drive Gear Shafts

ARL-TR-3827

June 2006

The objective of this report is root cause determination for the 15-hp spare drive gear failure.

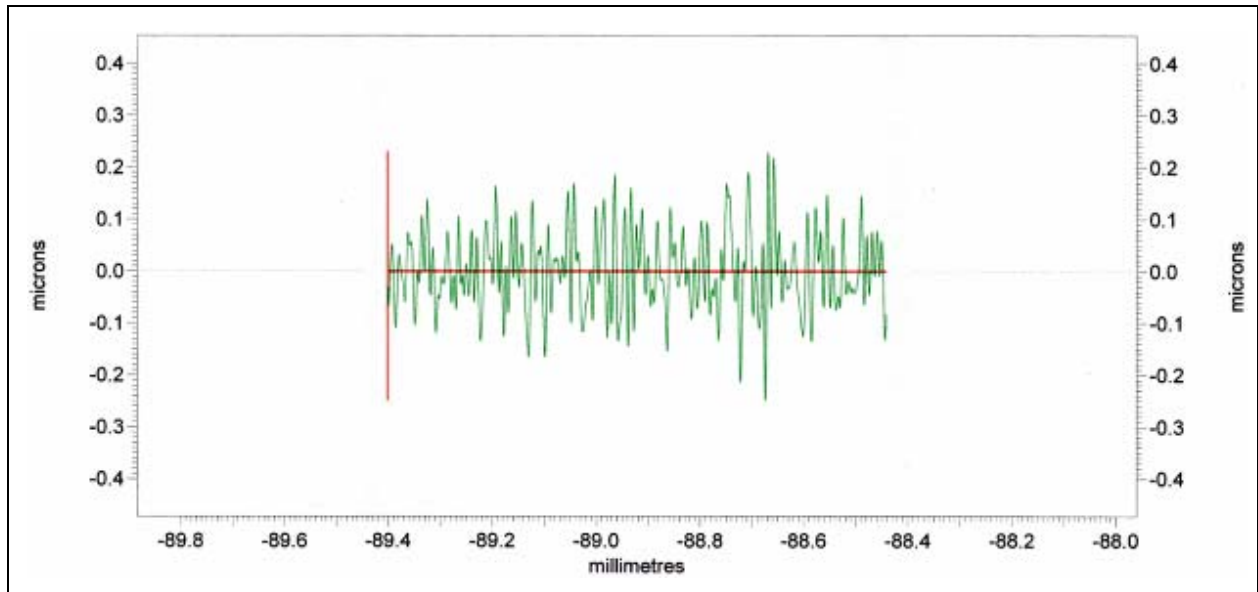
Figure 80. Surface roughness measurement.

A Taylor-Hobson Form TalySurf Series 2 was utilized to perform laser surface profilometry in a non-worn area of a typical gear tooth. The root mean square (RMS) surface roughness was measured to be 2.85 $\mu\text{m-in}$ (see figure 80). This is well below the specified value (32 $\mu\text{m-in}$). It must be noted that this measurement was on the surface of a tooth that may have been polished by the mechanical action of the meshing gear teeth during service, although no appreciable wear was observed in the area where the measurement was taken. Additionally, evidence of shot peening was observed (see figure 81). Measurements in the root of the teeth were unobtainable.

The surface finish was estimated to be 2.85 $\mu\text{m-in}$, RMS. This is within the drawing specification (32 $\mu\text{m-in}$ maximum). However, tool marks were observed near the roots of gear teeth.
